Mach Lake Dam (MO 30133).  
Mississippi - Kaskaskia - St. Louis River  
Basin, Perry County, Missouri. Phase I  
Inspection Report.

SUBJECT: Mach Lake Dam Phase I Inspection Report

MACH LAKE DAM  
PERRY COUNTY, MISSOURI  
MISSOURI INVENTORY NO. 30133

PHASE I INSPECTION REPORT  
NATIONAL DAM SAFETY PROGRAM

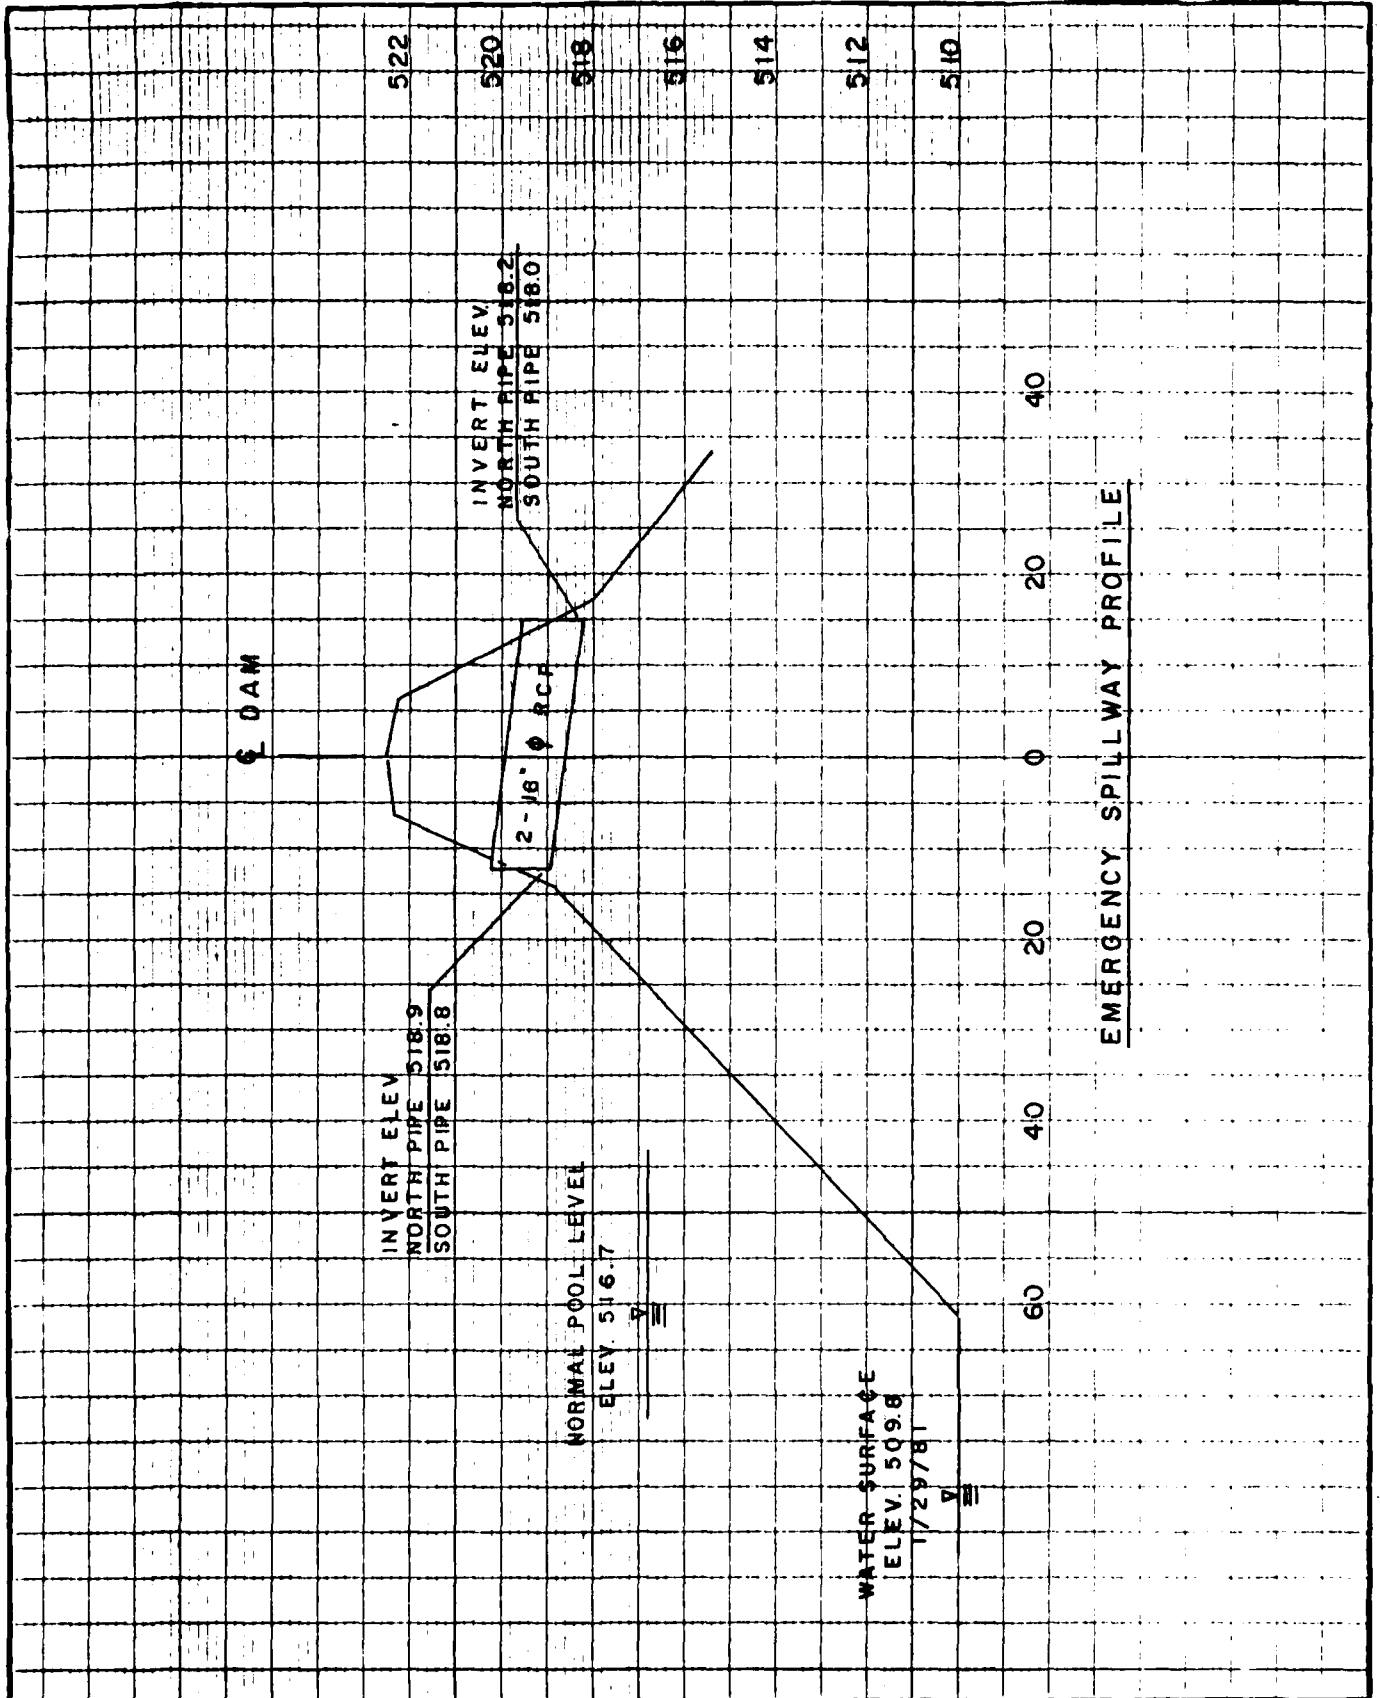
**SHEET 4, APPENDIX A**

A large inactive slough was noted on the downstream face of the embankment. The slough was at station 1 + 50 and at about the mid-height of the dam. The slough was approximately 25 feet across and a large mound of soil was at the base of the slough. The slough appears to be a slope failure and may be the slide referred to in the Geologist's report of April 6, 1973 (see sheet 4 of Appendix B).

- (1) Seepage and stability analyses comparable to the requirements of the recommended guidelines should be performed by an engineer experienced in the construction of dams.
- (2) The slough area at midheight on the downstream face should be maintained.
- (3) The briar and brush growth should be cut periodically.
- (4) Wave protection should be provided for the upstream face of the dam.
- (5) The plunge pool and around end of principal spillway should be riprapped.
- (6) Eroded areas at the dam-abutment contacts should be repaired and maintained.
- (7) The small water area in the downstream channel should be maintained to be sure this is not seepage under the dam.
- (8) Brush and tree growth should be removed from the spillway channel.
- (9) A detailed inspection of the dam should be made periodically by an engineer experienced in the design and construction of dams.

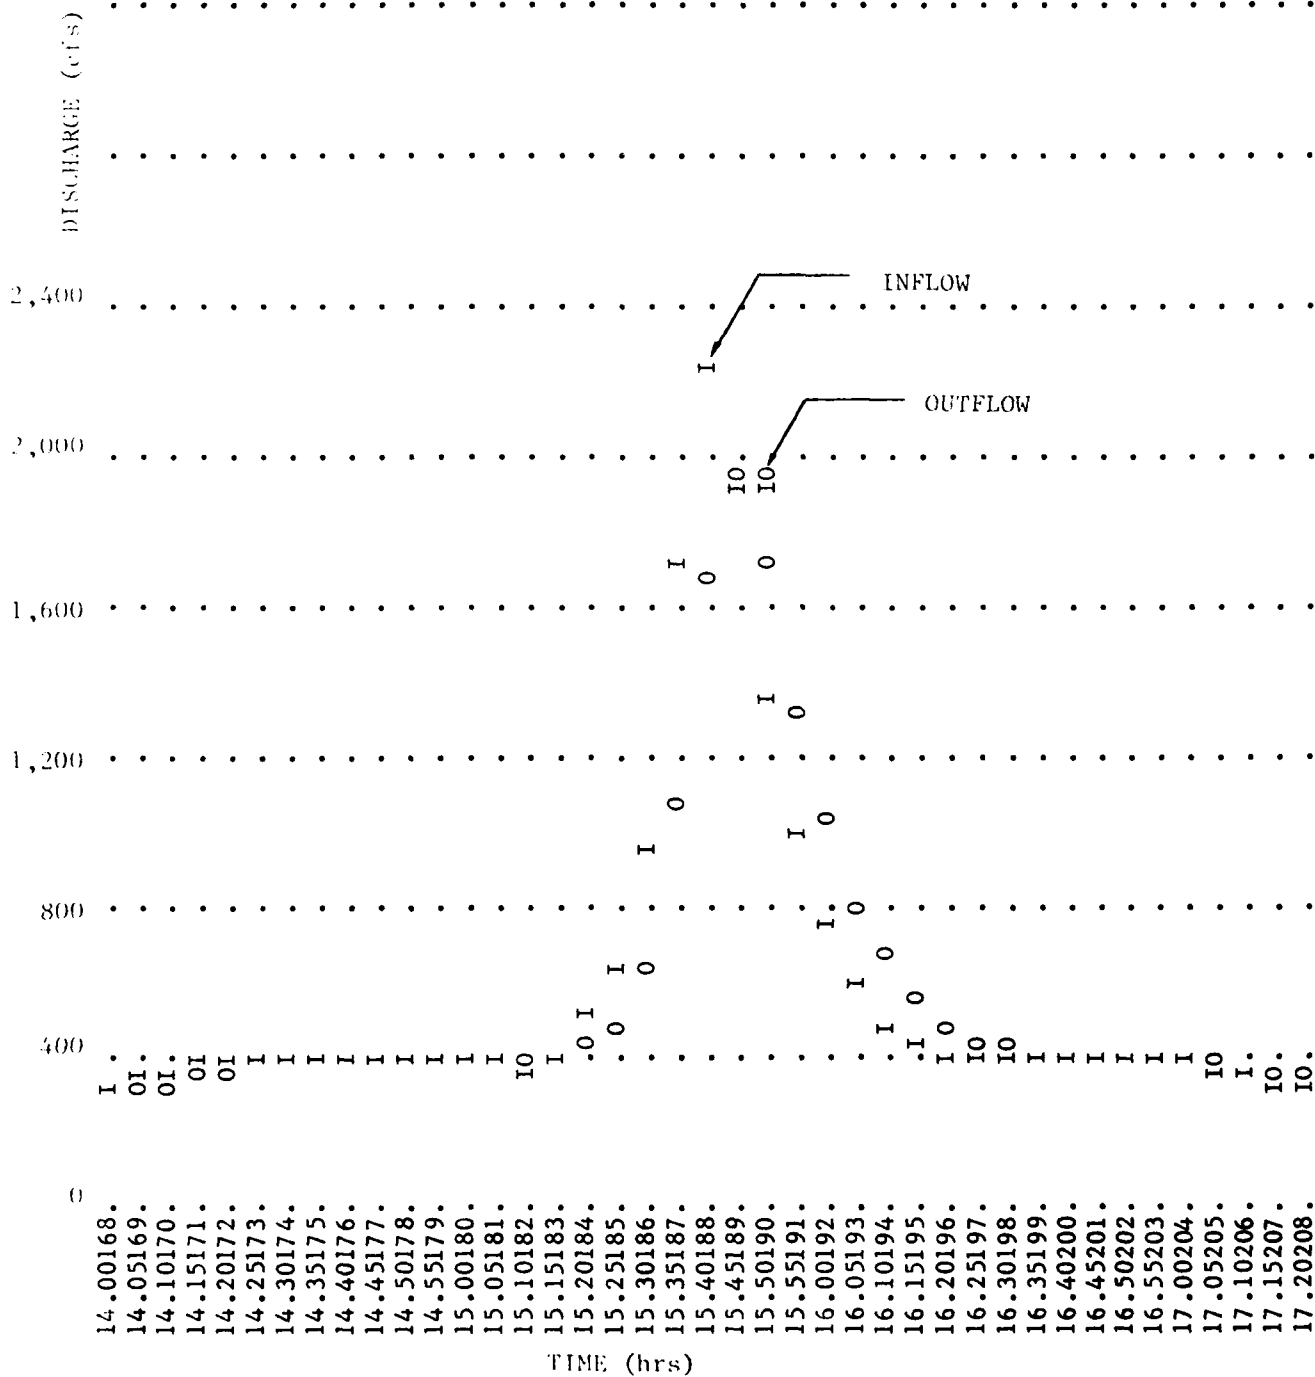
INFLOW-OUTFLOW HYDROGRAPH  
FOR THE PMF

The routing of the PMP through the spillways and dam indicates that the dam will be overtopped by 2.2 feet at elevation 522.8. The duration of the overtopping will be 12.4 hours, and the maximum outflow will be 1,280 cfs. The maximum discharge capacity of the spillways is 24 cfs. The routing of 50 percent of the PMP indicates that the dam will be overtopped by 1.5 feet at elevation 522.1. The maximum outflow will be 910 cfs, and the duration of overtopping will be 8.9 hours. Overtopping of an earthen embankment could cause serious erosion and could possibly lead to failure of the structure.
